# BC Accident Statistics

# Accidents / Fatalities

# BC Accident Summary - 2013

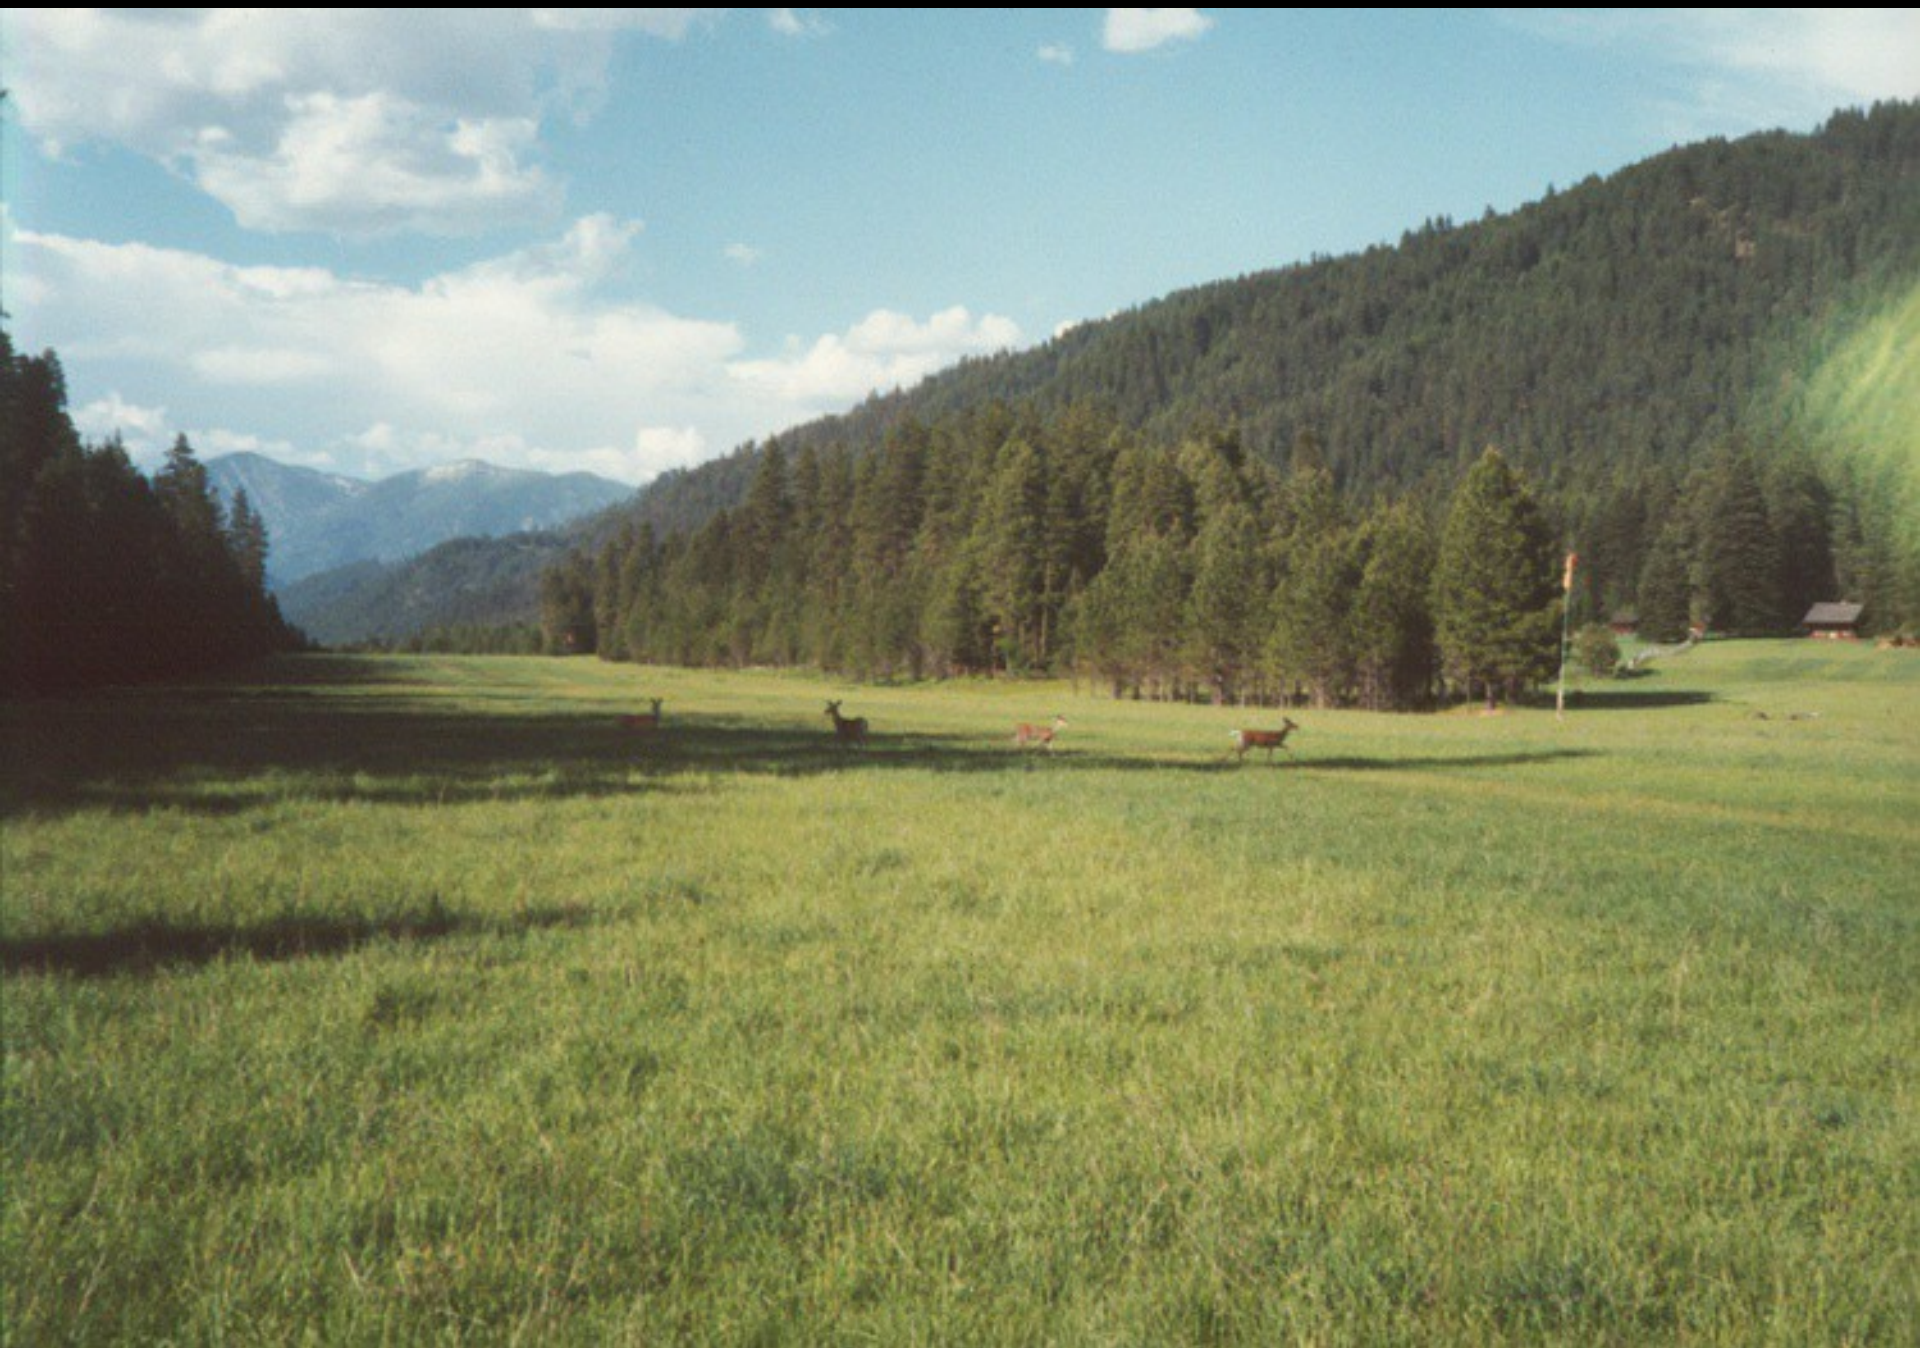
Soft in the middle of the runway  
- New Meadows

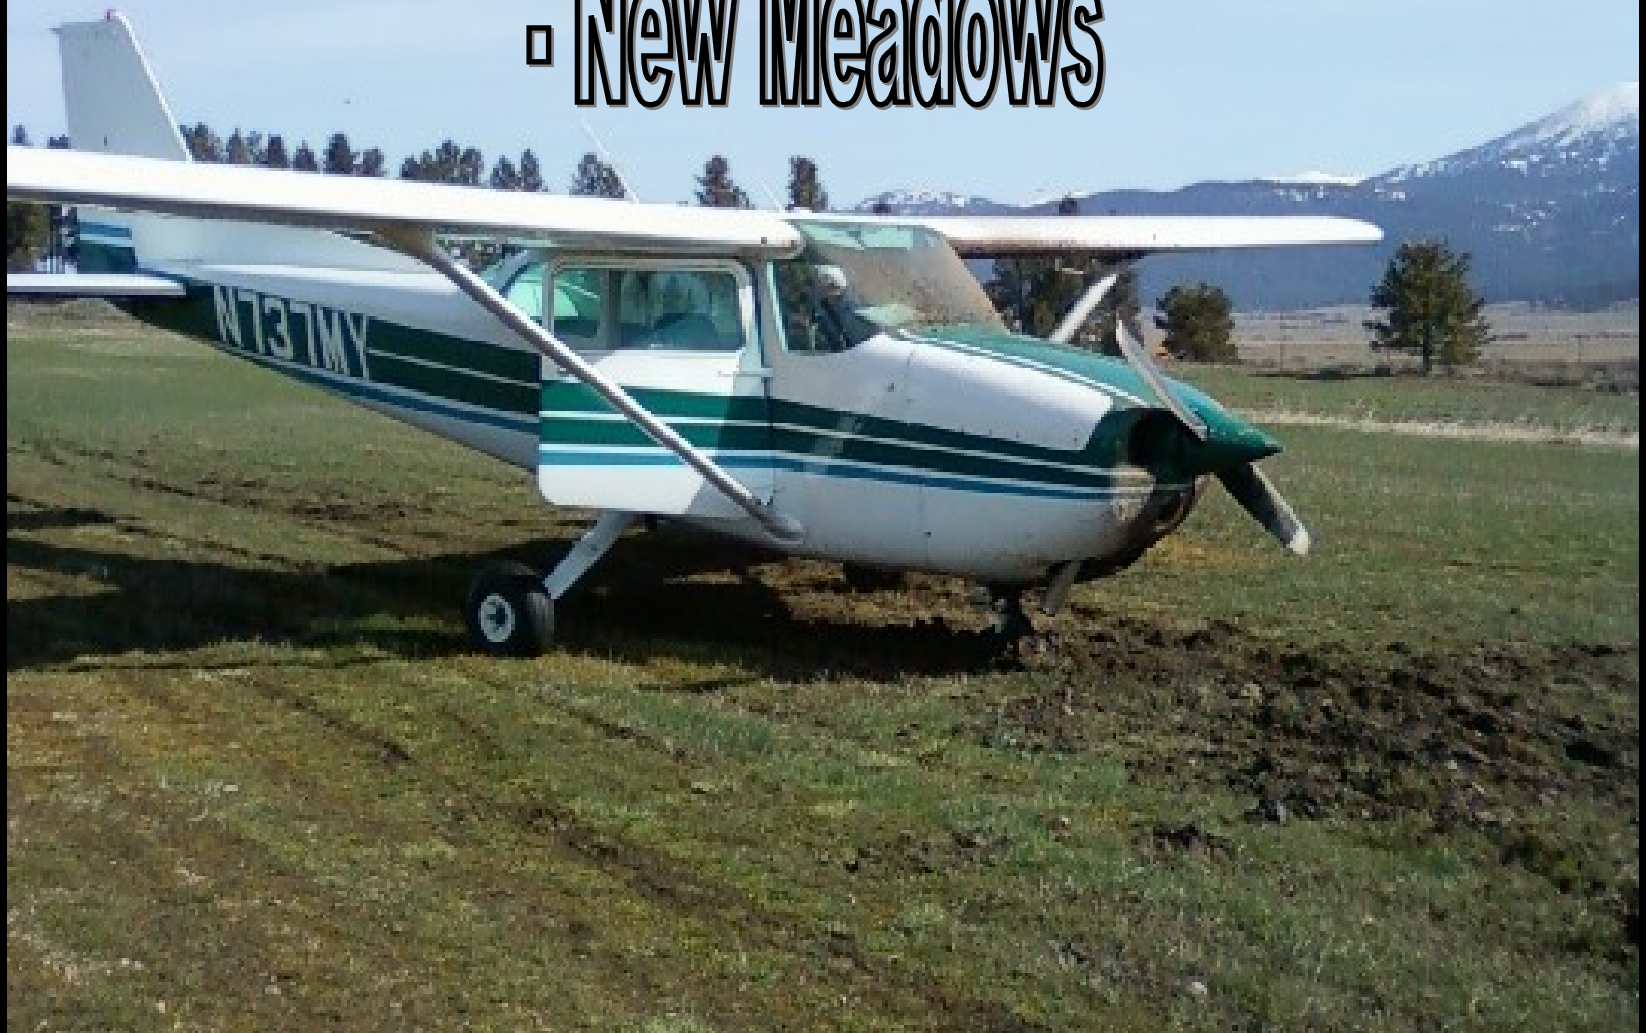
C182 - Overloaded -tailwind - take off stall

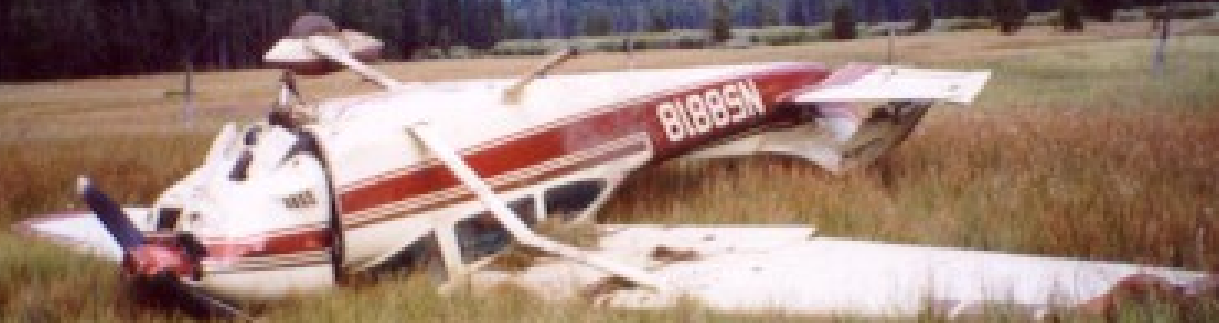
P210 - Too Low Approach - Sinking Air
